Inspection Report

123 Sample Report, Orlando, Florida 32819

Inspection Date April 19, 2019
Client Jane Doe
Inspector Owen Thompson
4079008336
contact@clearchoicehomeinspectionsservice.com

Clear Choice Home Inspection Service, LLC

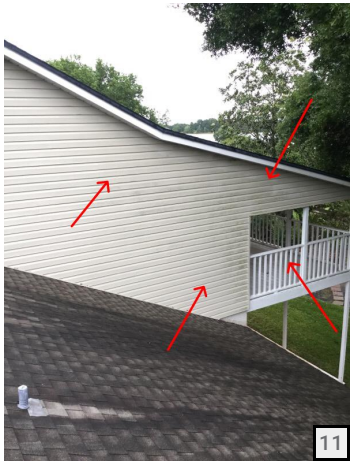
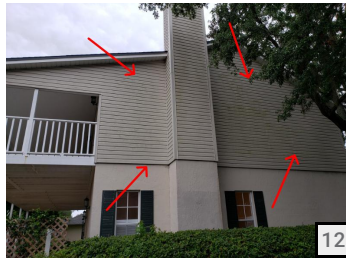
⊖ Foundation Wall

Possible Concern

Signs of mildew

Location Exterior: Ground View

1. Exterior: Ground View: Signs of mildew

Suggested Action Recommend pressure washing area

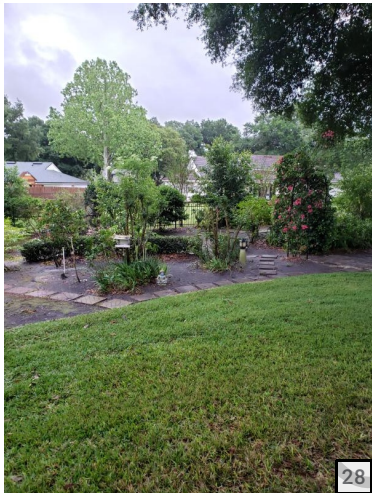
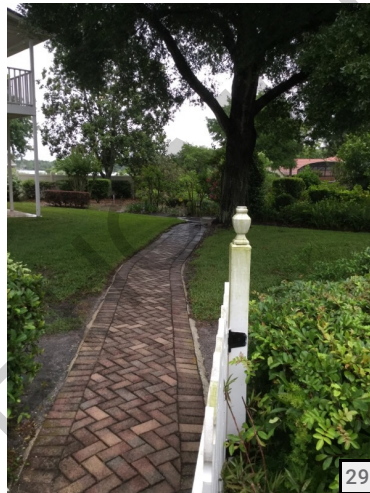
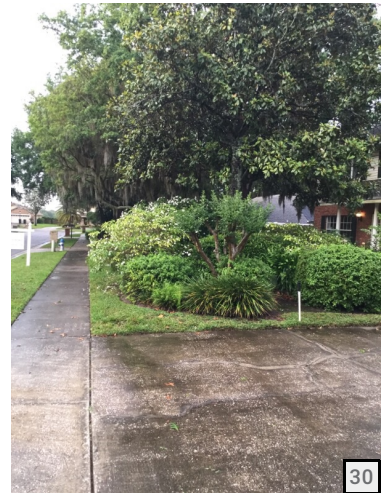
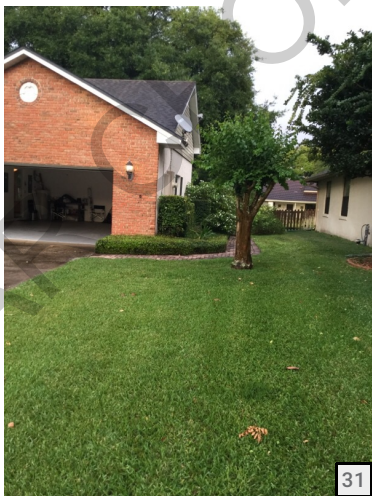
Minor Concern

Vegetation in contact with home

Location Exterior: Ground View

Impact Can result in mildew

3. Exterior: Ground View: Vegetation in contact with home

Suggested Action Vegetation should be at least 12 inches away from the house

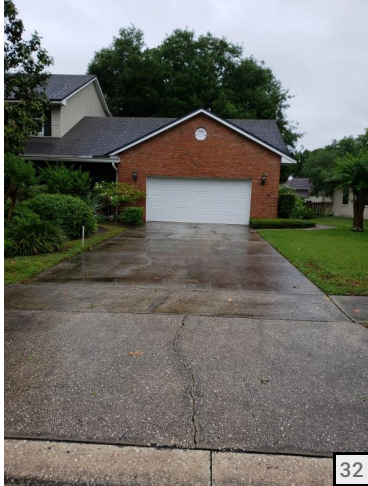
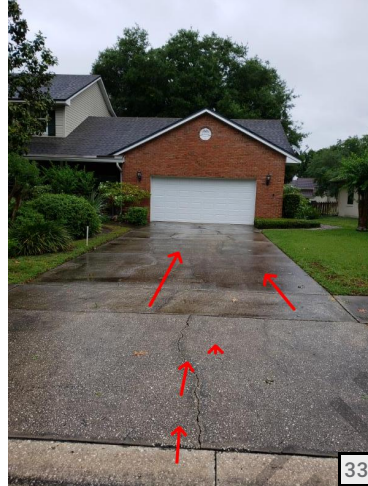
Minor Concern

Concrete is settling with minor cracks

Location	Exterior: Ground View
Impact	The cracks may allow for water intrusion.
Suggested Action	Seal the crack(s) with weather-resistant pliable concrete sealer
Estimated Repair Cost	\$\$\$ (1000-3000)

4. Exterior: Ground View: Concrete is settling with minor cracks

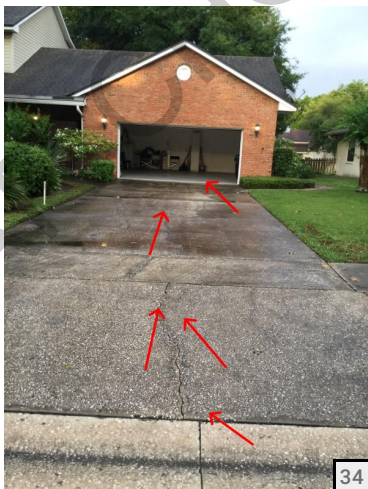
Observation to Monitor

Asphalt is cracking

Location	Exterior: Ground View
Impact	The crack allows water intrusion, which may cause the surrounding surfaces to also deteriorate possibly requiring a complete driveway replacement
Suggested Action	Sealcoat the driveway with an oil-based asphalt sealer and consult with a sealcoating contractor for a regular maintenance program based on the traffic and weather conditions
Estimated Repair Cost	\$\$\$ (1000-3000)
Other Information	All asphalt surfaces, that are not regularly sealcoated, dry out and fissure

5. Exterior: Ground View: Asphalt is cracking

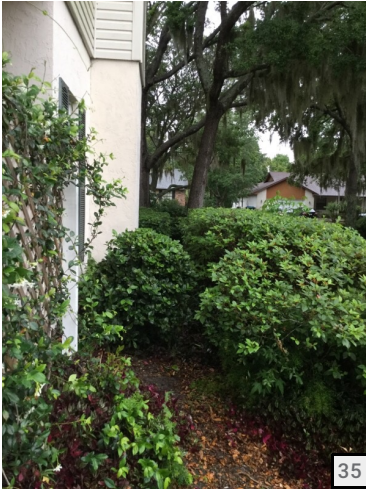
Observation to Monitor

Shrubby is in contact with home or siding

Location Exterior: Ground View

Impact The shrubbery provides an environment where moisture and/or insects could intrude

Suggested Action Regularly trim the shrubbery to achieve a clearance of at least 6 - 8 feet

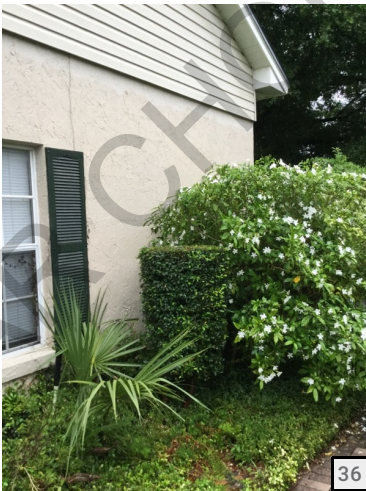
Observation to Monitor

Shrubby is in contact with home or siding

Location Exterior: Ground View

Impact The shrubbery provides an environment where moisture and/or insects could intrude

Suggested Action Regularly trim the shrubbery to achieve a clearance of at least 6 - 8 feet

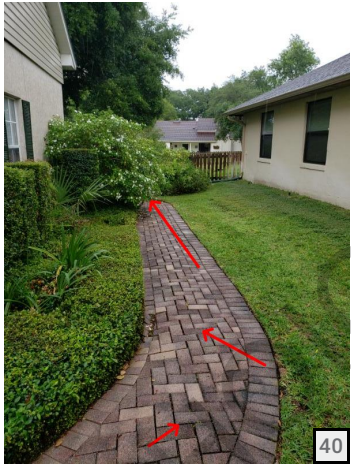
Moderate Concern

Paver or brick has significant settling

Location Exterior: Ground View

Impact The settling may allow moisture intrusion further damaging surrounding material

2. Exterior: Ground View: Paver or brick has significant settling

Suggested Action Remove the pavers, repair the base and reinstall the pavers

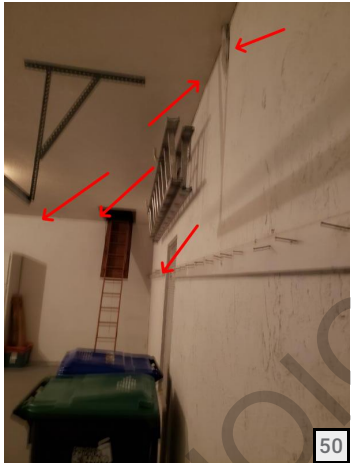
Observation to Monitor

Ceiling Drywall wall is cracking

Location	Attached Garage
Impact	The cracking may worsen causing Drywall to separate
Suggested Action	Have assessed by a Drywall professional

12. Attached Garage: Ceiling Drywall wall is cracking

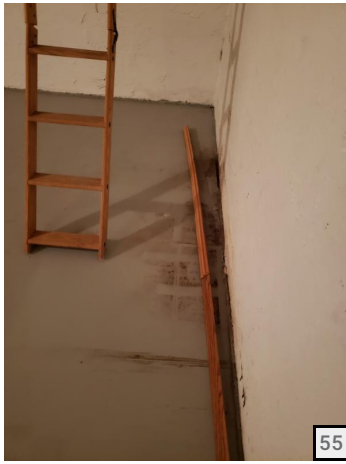
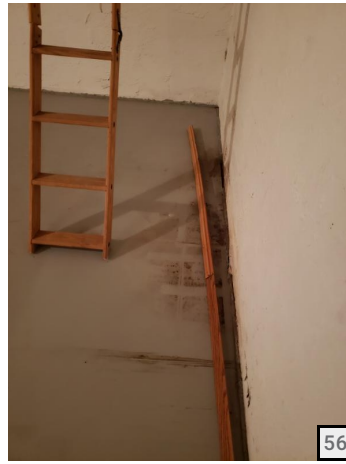
Major Concern

Concrete is cracking with evidence of moisture intrusion

Location Attached Garage

Moisture in the basement could cause damage to the flooring and can possibly create an environment conducive to mold growth

8. Attached Garage: Concrete is cracking with evidence of moisture intrusion

Repair by a licensed waterproofing contractor

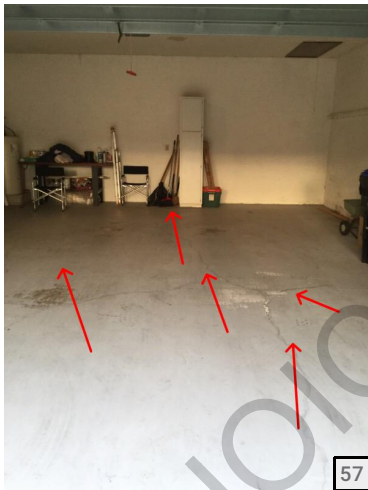
Minor Concern

Concrete garage floor has minor cracking

Location	Attached Garage
Impact	May further damage due to water or salt runoff from vehicles
Suggested Action	Fill the crack with expandable moisture resistant caulking
Estimated Repair Cost	\$\$ (500-1000)

10. Attached Garage: Concrete garage floor has minor cracking

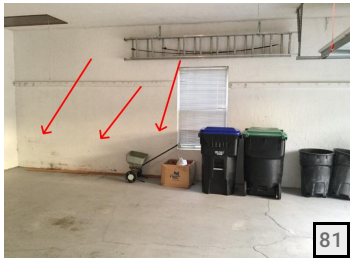
Moderate Concern

Moisture

Location Attached Garage

May cause paint to bubble and further damage may result such as mildew/mold growth

9. Attached Garage: Moisture

Have evaluated and repair by a general contractor.

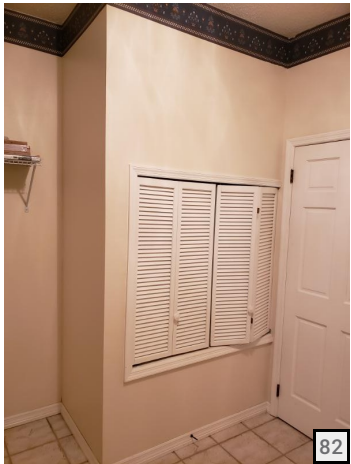
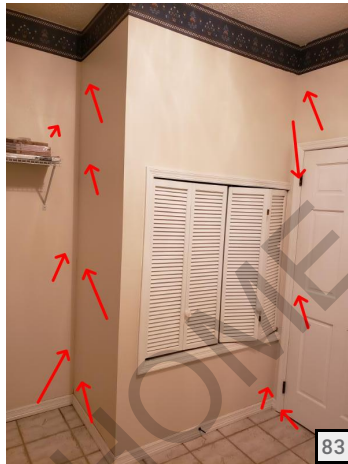
Cosmetic

Drywall Crack

Location Laundry Room / Mudroom
Suggested Action Patch and repaint

11. Laundry Room / Mudroom: Drywall Crack

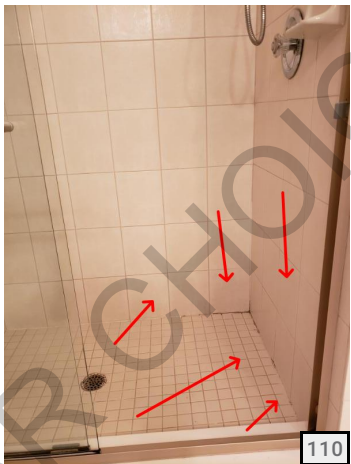
Moderate Concern

Moisture present in lower tiles

Location 1st Bathroom

Impact Moisture may leak into surrounding areas causing damage to floors and walls.

13. 1st Bathroom: Moisture present in lower tiles

Suggested Action To be evaluated by a professional Tiler

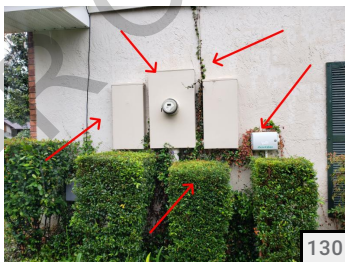
Safety Concern

Electrical panel have roots growing around

Location Exterior: Ground View

Impact Electrical shock

Suggested Action Recommend removing roots and Shrubs from electrical panel at least 12 inches away

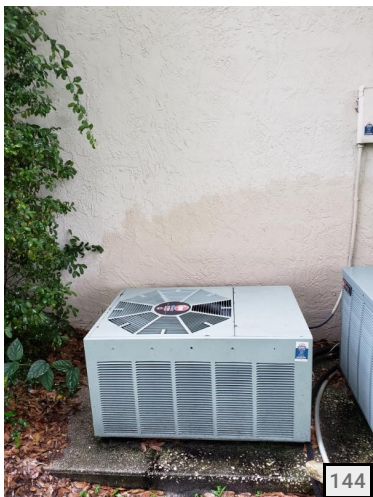
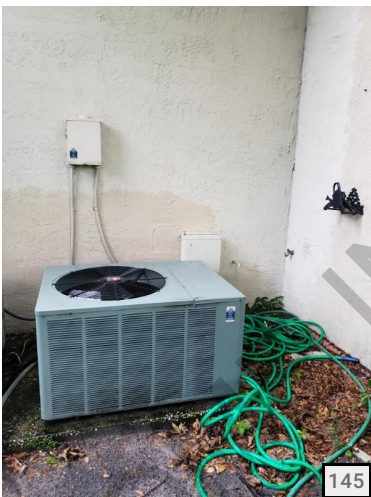
Old

The SMALL AC-Condenser is nearing the end of its useful life, It's a 2002 unit.

Location Exterior: Ground View
Suggested Action Budget for a newer unit. In the interim, a higher level of maintenance can be expected,

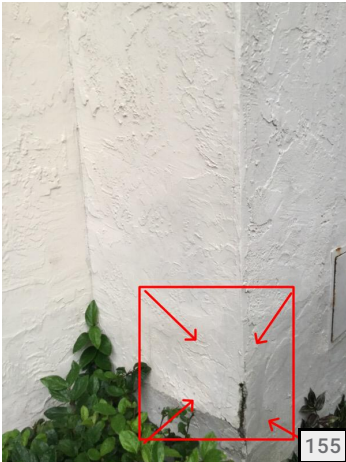
Moderate Concern

Chimney chase mortar is loose or deteriorating

Location	Exterior: Ground View
Impact	The damage may worsen and would need more extensive repairs
Suggested Action	Have spot-pointed by a qualified brick mason or tuckpointing technician to maintain optimal performance going forward

19. Exterior: Ground View: Chimney chase mortar is loose or deteriorating
