Inspection Report

123 Sample Report, Orlando, Florida 32819

Inspection Date April 19, 2019
Client Jane Doe
Inspector Owen Thompson
4079008336
contact@clearchoicehomeinspectionsservice.com

Clear Choice Home Inspection Service, LLC

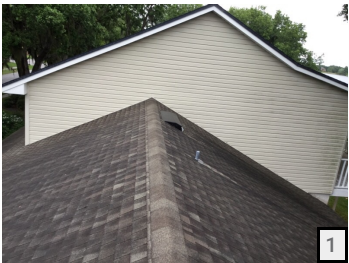
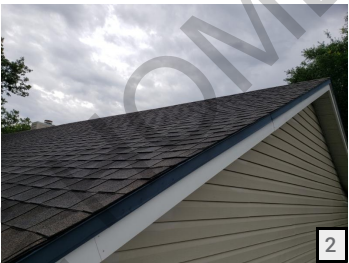
Roof

In Working Order

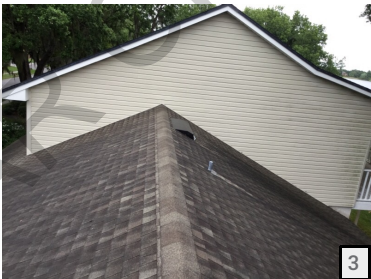
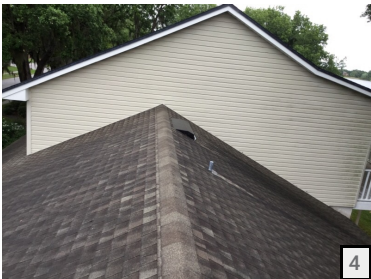
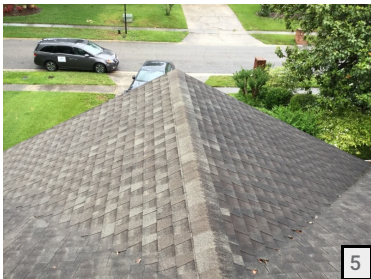
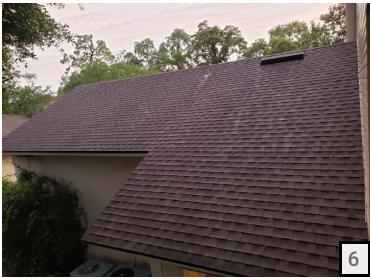
Roof

In Working Order

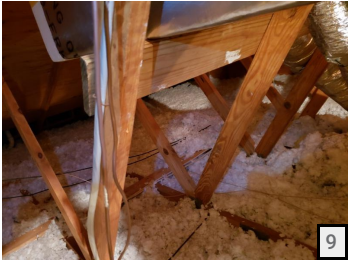
Insulation

In Working Order

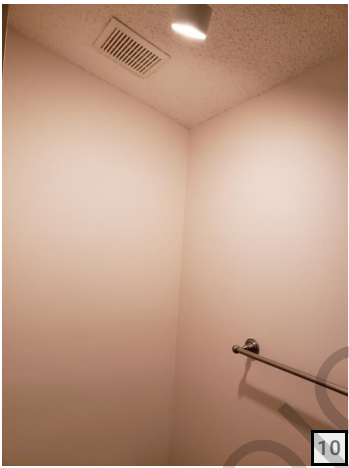
Bathroom Exhaust

In Working Order

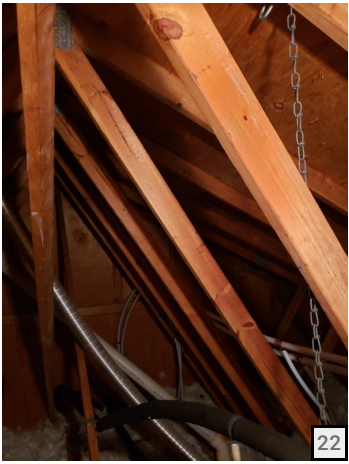
Truss

In Working Order

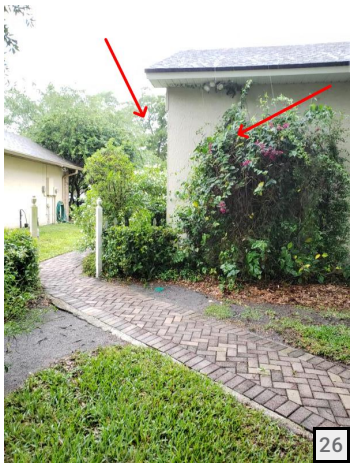
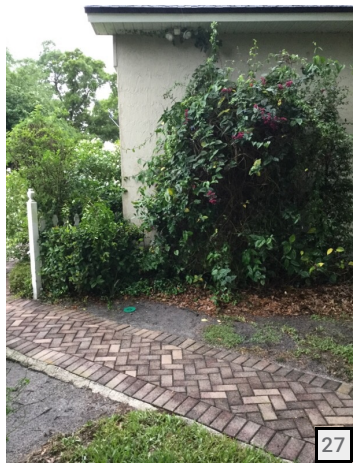
Impact Can result in mildew

Suggested Action Vegetation should be at least 12 inches away from the house

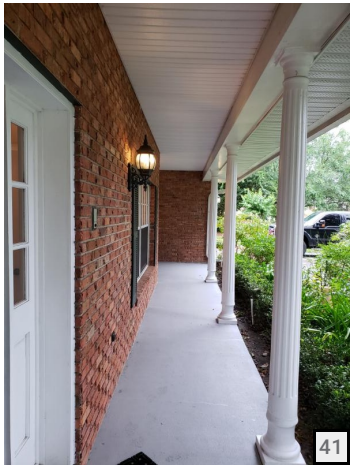
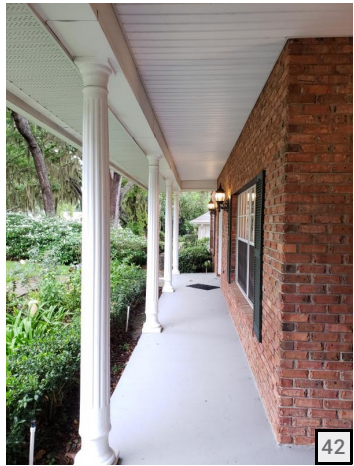
Front porch

In Working Order

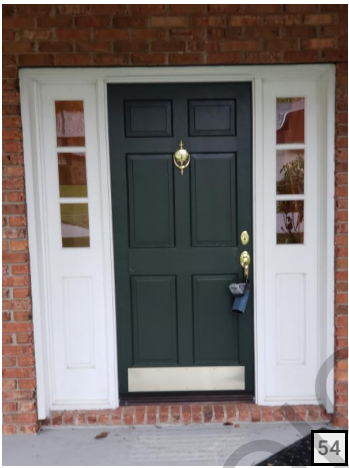
Front Door

In Working Order

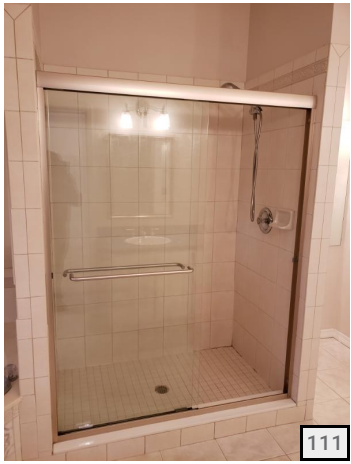
Location 1st Bathroom

Moisture present in lower tiles

Impact Moisture may leak into surrounding areas causing damage to floors and walls.

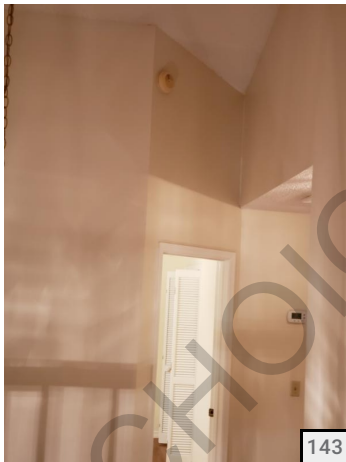
Location Hallway and Stairs

Missing

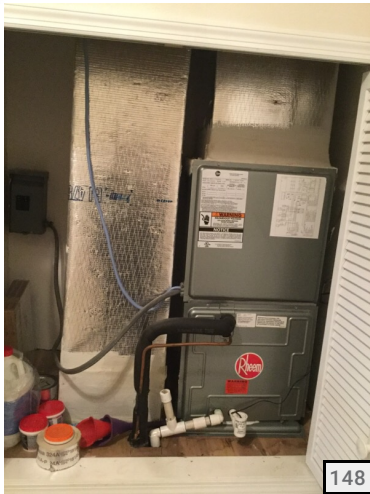
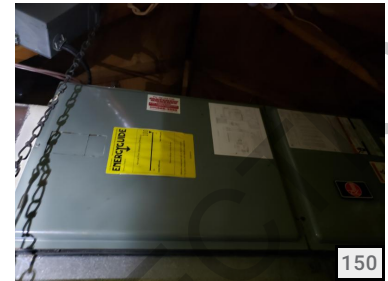
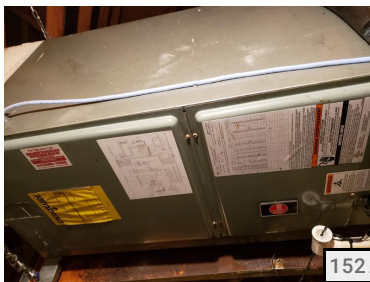
Air-Handler

Location Attic, Laundry Room / Mudroom

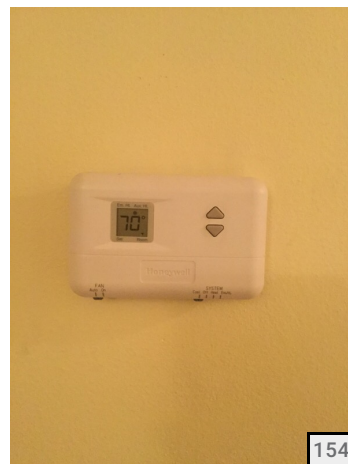
Thermostat

In Working Order

Location Hallway and Stairs

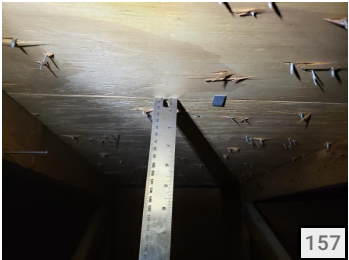
7/16 Sheathing

Location Exterior: Ground View

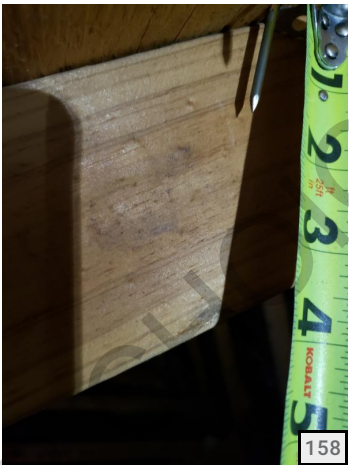
Nail

In Working Order

Location Exterior: Ground View

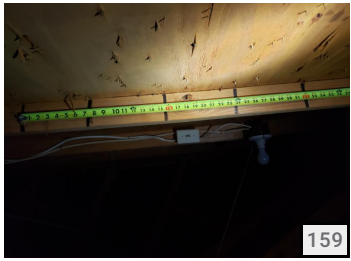
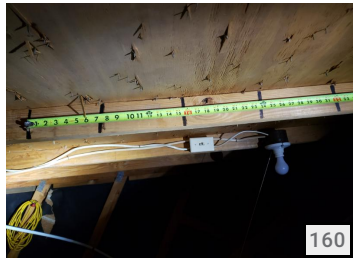
Roof to Deck

In Working Order

Location Exterior: Ground View
